NAVY DEPARTMENT
BUREAU OF NAVIGATION

CASE INSTRUCTION

SERIAL NUMBERS 1 TO 10
COLLISION CASES

*Prepared by the
Training Division
Bureau of Navigation*

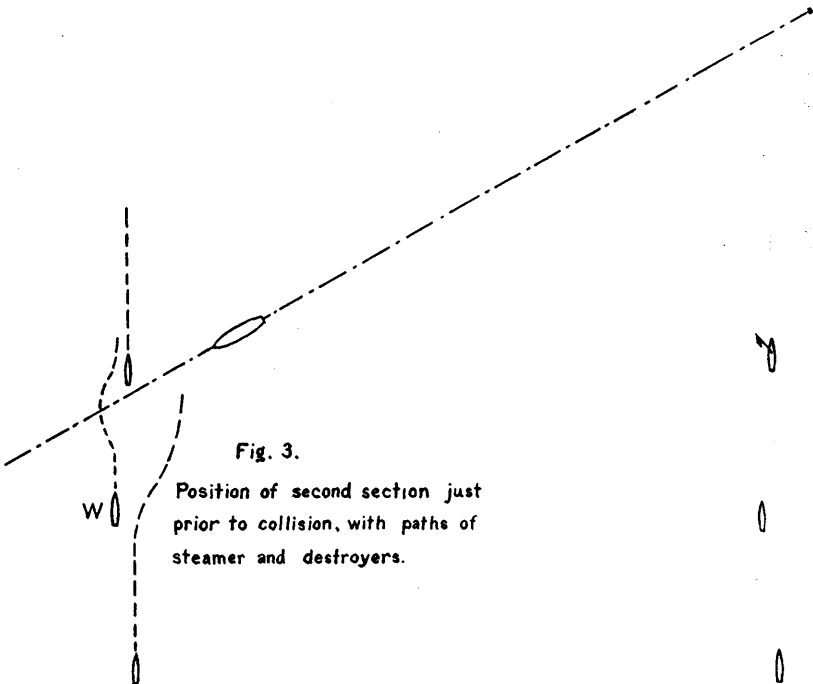
About 0100 the officer of the deck of *Wren* noted a change in the relative position of the range lights of the steamer and realized that she was changing course to her starboard. It was believed that the steamer's intention was to stand down through the lane of water between the sections. But as the steamer continued to swing it was seen that this was not going to be attempted. The *Wren's* officer of the deck observed the steamer's range lights close, and then

the side lights open. Both side lights continued to be seen, though from his testimony he expected to see the red one shut out and the steamer swing down through the lane between the two sections. The range lights were in line, and both side lights were seen until the steamer was well past the middle of the lane.

At this point the green light was shut out, and it appeared that the steamer was going to try to pass ahead of the section.

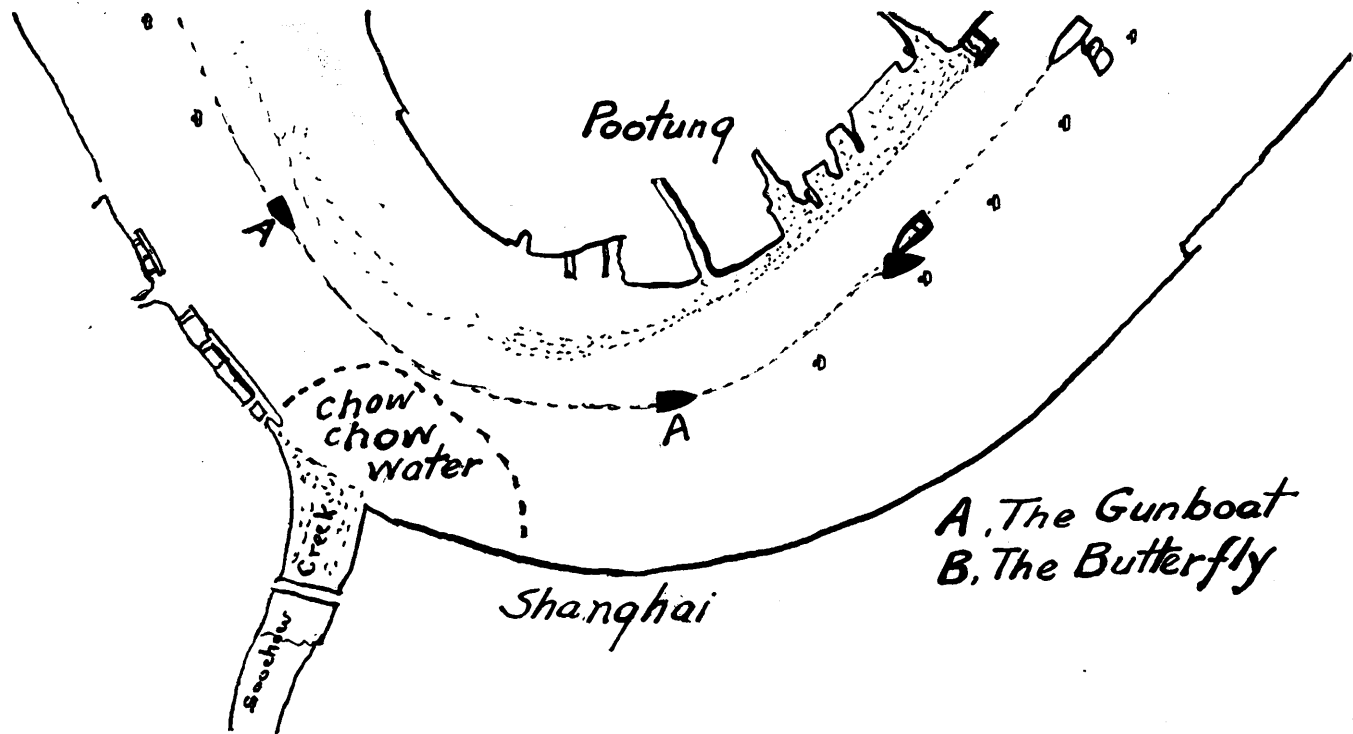
A river gunboat was standing up the Whangpoo River, China, to her assigned moorings off the French City, Shanghai. The weather was clear, the wind light airs, and tide flood. About 0800, that morning, she was rounding the bend where Soochow Creek enters. From about a mile above to a mile below the Soochow Creek the river has mooring buoys in the middle.
